Manhole Inspection Summary

Manhole # S13C1_006MH

Insp Date: **3/7/08 11:07 AM**

Location Address: **1421 S Caton AV**

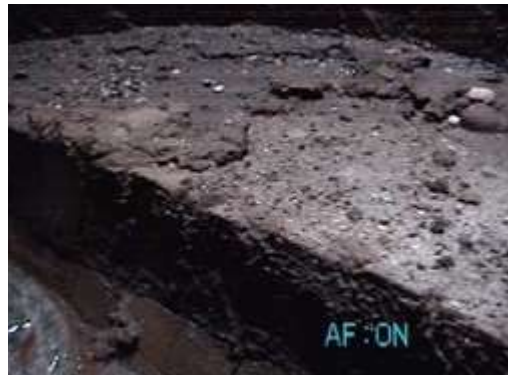
debris on bench

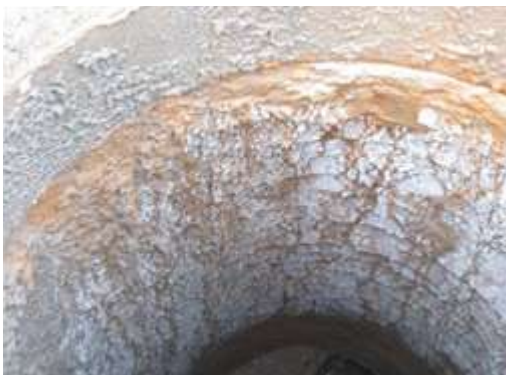
Defect 7

infiltration at chimney and corbel

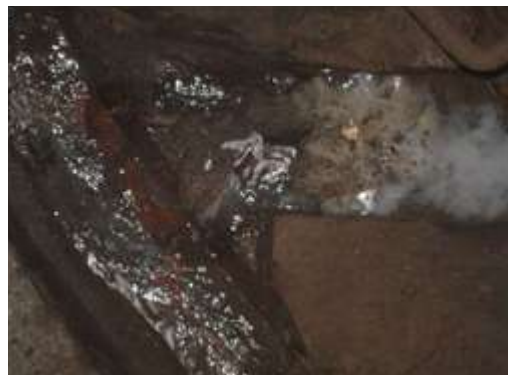
Defect 6

debris blocking the 3 oclk channel

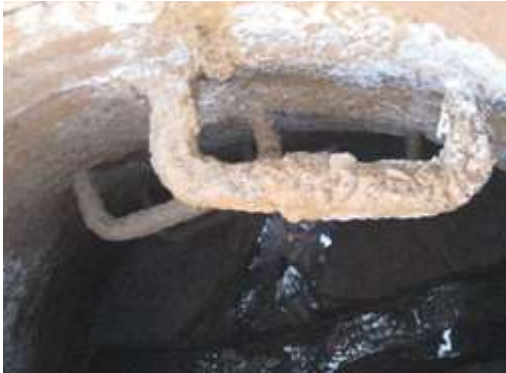
Defect 5

rusted rungs

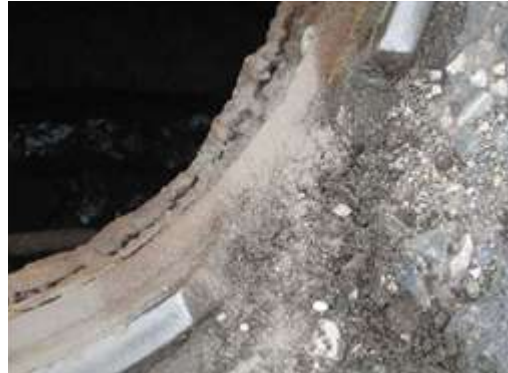
Defect 4

2oclk cracked frame

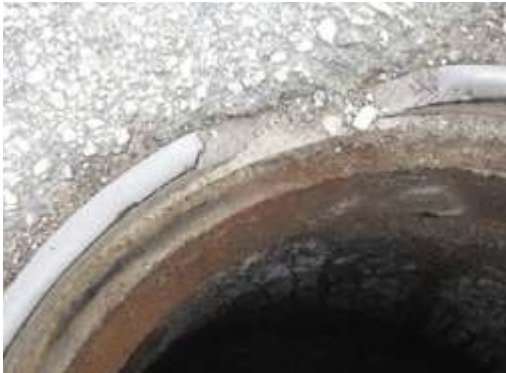
Defect 3

cracked frame at 10 oclk

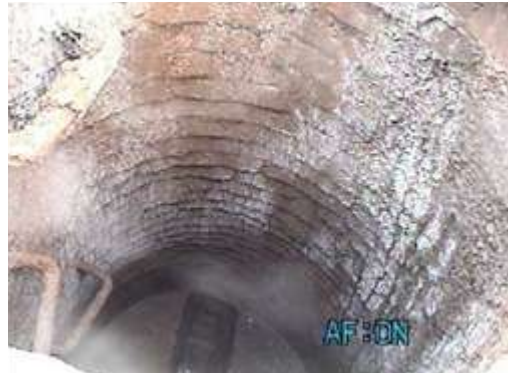
Defect 2

signs of infiltration in corbel

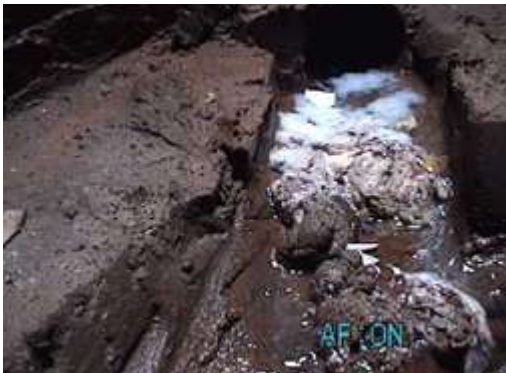
Defect 1

debris in channel

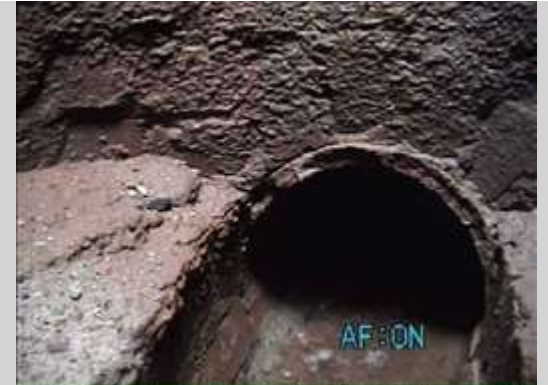
12 O'Clock Outflow

10 in. Circular Gravity Sewer
Pipe Out @ 12 O'Clock

Pipe Height: **10.8** (in.) Rod and Bar (Angled)
Pipe Material: **Clay** ☐ Pipe Lined
Invert Depth: **8.14** (ft.) Flow Characteristics: **Slow**
Deposits: ☒ None ☐ Mud ☐ Sludge ☐ Debris ☐ Grease
Silt Depth: **0** (in.) Deposits Extent:
Infiltration: **None** Pipe Seal Cond: **Sound**

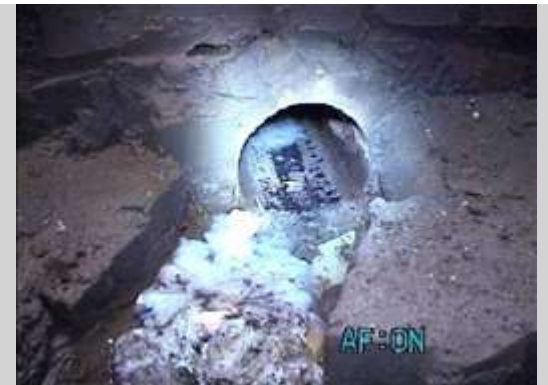
3 O'Clock Inflow

6 in. Circular Gravity Sewer
Pipe In @ 3 O'Clock

Pipe Height: **6** (in.) Rod and Bar (Angled)
Pipe Material: **Clay** ☐ Pipe Lined
Invert Depth: **7.62** (ft.) Flow Characteristics: **Slow**
Deposits: ☒ None ☐ Mud ☐ Sludge ☐ Debris ☐ Grease
Silt Depth: **0** (in.) Deposits Extent:
Infiltration: **None** Pipe Seal Cond: **Sound**

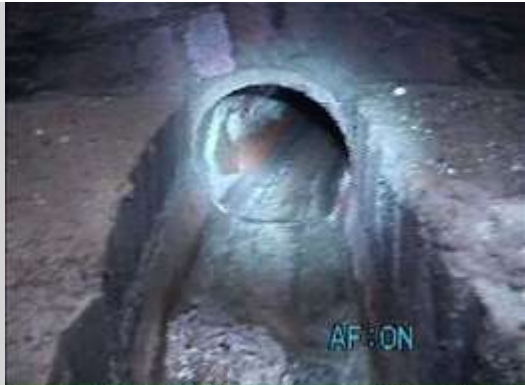
5 O'Clock Inflow

8 in. Circular Gravity Sewer
Pipe In @ 6 O'Clock

Pipe Height: **8.4** (in.) Rod and Bar (Angled)

Invert Depth: **7.84** (ft.) Flow Characteristics: **Slow**

Infiltration: **None** Pipe Seal Cond: **Sound**
